MPT High Performance Full Manual Valve Body

Additional parts Instructions

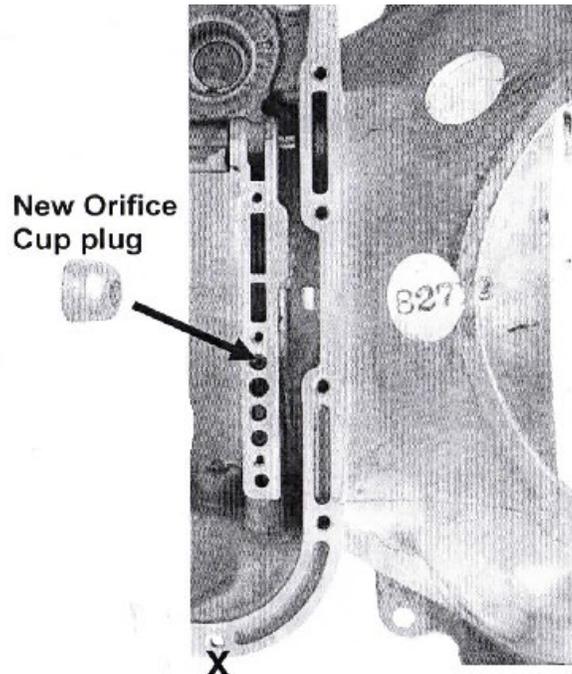
Install Orifice Cup Plug in this case orifice * (Helps alleviate 2-3 shift overlap)

* Cup plug is usually not required in a **variable pressure** setup.

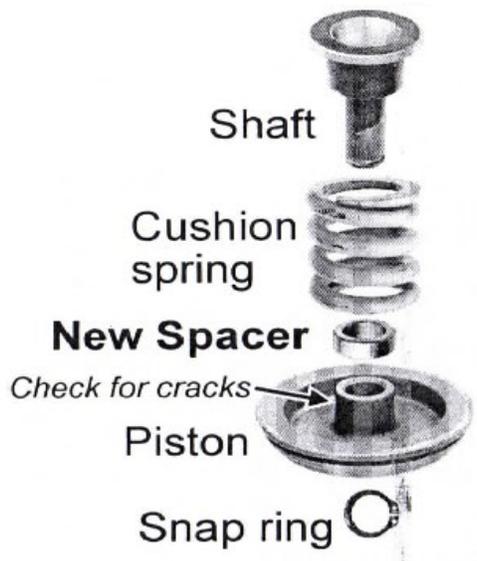
Install Rear Servo Spacer (Helps alleviate 1-2 Shift Overlap).

Used in both **Constant Pressure** and **Variable Pressure** set-ups.

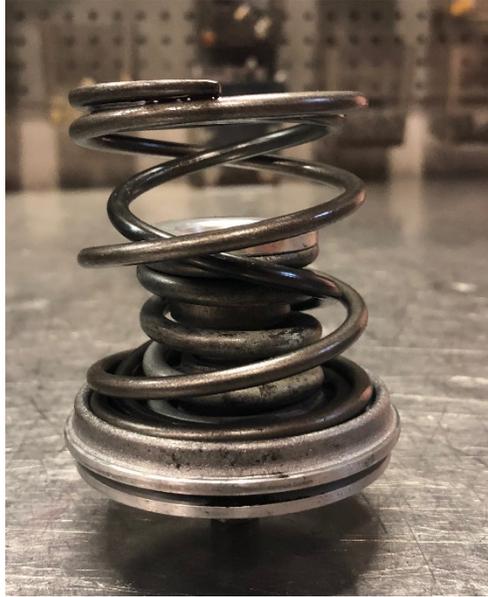
Install included spring into rear servo.

This further helps to alleviate 1-2 shift overlap. **Constant Pressure:** The new spring will sit inside the stock spring. See picture below. You will have to work at getting the retaining clip that holds the servo in place – it really helps to have a second set of hands for this step.

Variable Pressure: Low/ reverse servo does not need to be double-sprung. Instead, remove the factory intermediate (kickdown) servo spring and solely install the included heavy gauge intermediate servo spring.

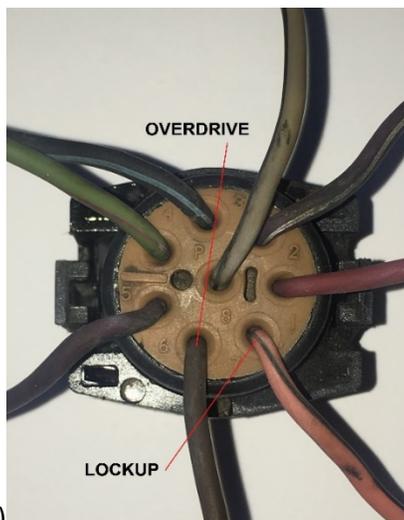
Transmission Wiring ID

Pin 1 is +12V Ignition On Power (You must run independent 12-volt ignition on power supply *)

Pin 6 is Overdrive

Pin 7 is Lockup

* This is required because the governor pressure solenoid and transducer are disabled in a full manual valve body, so the truck will no longer supply power to the existing pin 1 line.

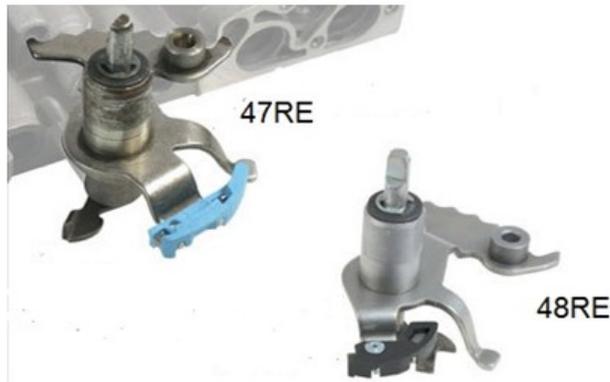
Rooster Comb ID

If you are installing our full manual valve body into a 03+ 47/48RE, you will have to swap rooster combs from your core valve body. We do not ship full manual valve bodies with 48RE rooster combs, as many times they get damaged in shipping, (cores are not packaged properly and we get damaged 48RE rooster combs returned). If you send us a 48RE core valve body before we send your full manual valve body out, we will build it with your 48RE rooster comb. In any case, your core return to Muldoon's Performance Transmissions must include a rooster comb in order to qualify for a full core refund.
